SERVICE BULLETIN

SUBJECT: Barrels of architectural sex bolts *may* come into contact with shim plate and causing an improper fit or *may* cause excess vibration on lock. This occurs on certain wood doors which are less than 1.75" thick or when sex bolt screw has been over-torqued and wood door is compressed.

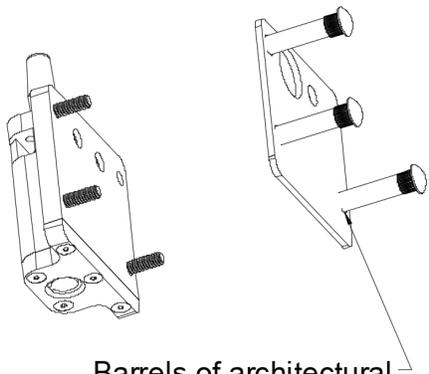
Barrels of architectural bolts should NOT come into contact with shim plate on occupancy side of door.

Repair shim plate by drilling 3 - 13/32" holes through plate. This will provide for ample headspace at end of architectural sex bolt barrel. Alternatively, shim plates may be exchanged for a new one by contacting us at service@teacherlock.com
